Wrecks.

BY WILLIAM G. FITZGERALD.

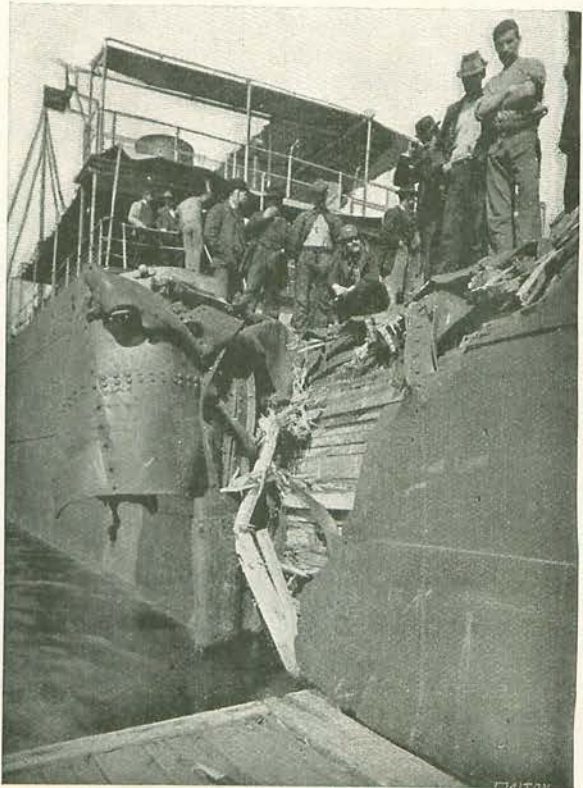
It will be seen in the accompanying photo. that the vessel depicted has been struck a glancing blow. The name of the ship is the *Neptune*. Her iron plating has been crumpled up as though it were tin, and much of her wood-work splintered. The blow from the

"A GLANCING BLOW."

colliding vessel was neither heavy nor serious, but, nevertheless, it inflicted £2,000 or £3,000 worth of damage.

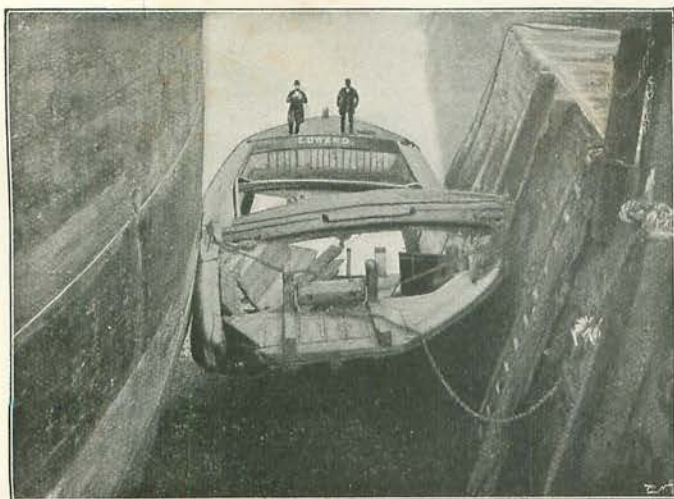
HOW THE BARGE GOT CRUSHED.

The photo. next reproduced shows a very curious accident. A great ship was lying in dock, like scores of other great ships. Between her and the side of the quay was an ordinary barge. The name of that barge was *Edward*—just plain *Edward*. Well, the tide fell, and the big vessel heeled slightly over, crushing up the barge as she did so like an egg-shell. The photo. shows *Edward's* trying position—not exactly between the devil and the deep sea, but between a big, remorseless ship and an equally unyielding quay-wall. It was unkind of the big ship, because *Edward* had probably brought sup-

plies for her. It was an ill turn, in fact, and *Edward* felt hurt. His main-stay was gone, as you can see in the photo. His case—which he brought into court—was that he was lying low sayin' nuffin', when suddenly his big brother turned upon him and rent him. He was awarded £300 as a solatium. This shows us that the rights of the humblest craft are respected, as well as those of the "kings" of the high sea.

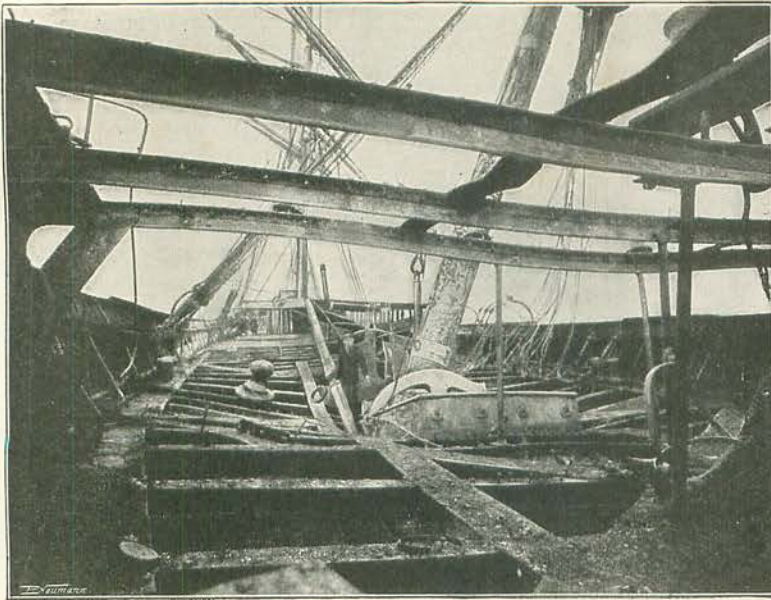
A CASE OF SPONTANEOUS COMBUSTION.
From a Photo. by W. H. Franklin, Deal.

A ship that fired by spontaneous combustion is here depicted. This is the *Micronesia*, and hers was a curious case. Her total value was about £6,000, yet, as she was insured for £13,000, her owner recovered that sum in the most legitimate manner possible. The fire seems to have run along the whole of the bags of nitrate which formed the cargo, and burned every scrap of woodwork in the skin of the vessel. This peculiarity is noticeable in the photo. The *Micronesia* was at length taken in tow by a tug and beached at Deal. The nitrate, usually soft and powdery, became as

hard as rock, and had to be removed with pickaxes.

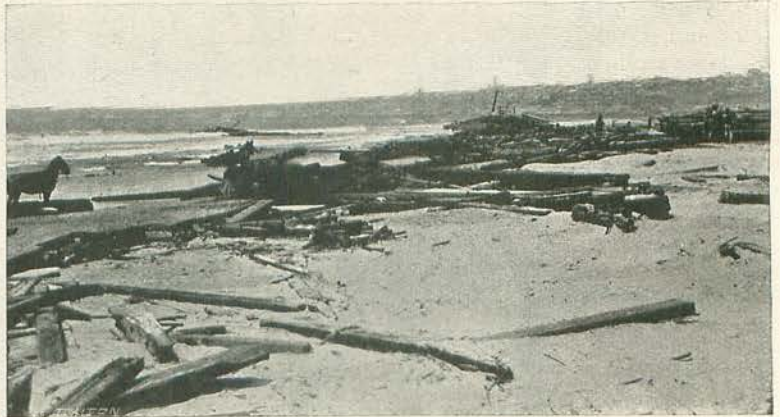
ALL THAT WAS LEFT OF THE "REISBAD."
From a Photo. by Messrs. Goldsborough & Son, Port Elizabeth.

The remarkable photo. next reproduced shows a "wreck" indeed. The beach is literally strewn with the wreckage of the ill-fated barque, *Reisbad*, which was wrecked near Port Elizabeth, South Africa.

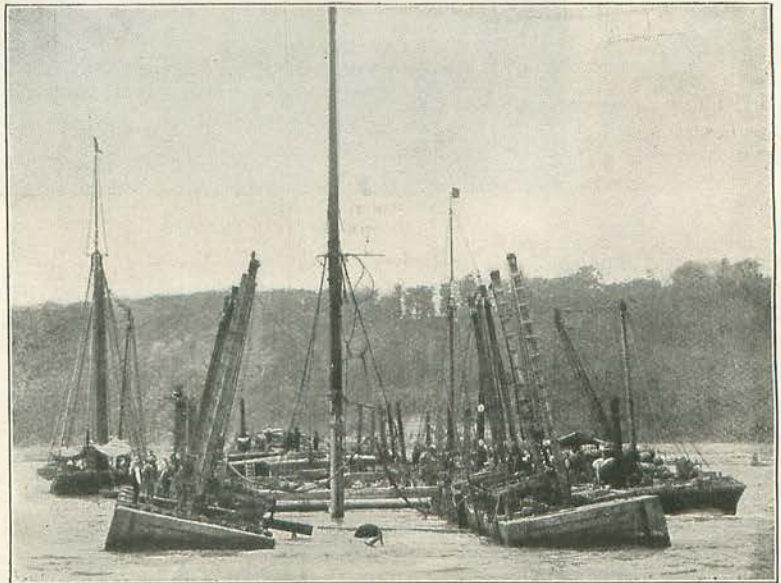
It seems to be the principle of the merchant marine, that as long as a ship holds together, above water or below, hope is never to be abandoned. You will be surprised to learn, considering the "tight place" the ship is in in the photo., that the *Wells City* was not only raised and repaired, but is still

The whole process of lifting a sunken vessel is next depicted. The high mast in the middle of the photo. belongs to the wrecked ship, whose hull lies far beneath the water. On the surface is a scene of great activity. The curious floating structures on either side are the pontoons, which are probably made fast with chains to the vessel below. Cranes, steam pumps, tugs, and diving apparatus—all these are in readiness for the salvage operations. The lifting process shown in the photo. took place in New York Harbour, and the wreck is that of the *Wells City*, a huge steamer of 3,000 tons. She had a valuable cargo of tin-plate goods and hardware, but was sunk in 50ft. of water, through a collision with another vessel. The total cost of

SHOWING HOW THE "WELLS CITY" WAS LIFTED.

salving the *Wells City* was close upon £20,000. Most of the plant was provided by the Isaac Merritt Company, of New York.

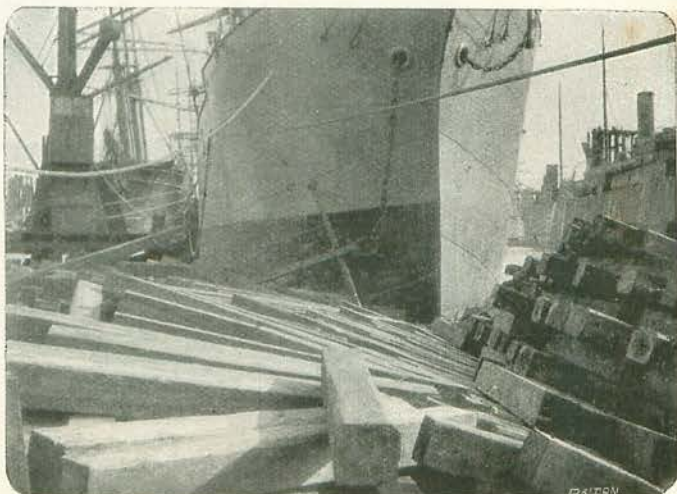
The accident to the Norwegian vessel *Turiste*, which is next shown, was one of the most remarkable in maritime records. The *Turiste* lay in Barry Dock, Cardiff, on October 6th, 1896. Floating around, "permiscous-like," were sundry enormous stacks of timber, and it was one of these that virtually wrecked the *Turiste*. As a fact, the timber-stack began to go to pieces, but instead of toppling over and injuring the vessel that way, the stack began to break up *under water*. The result was that hundreds of big logs worked their way beneath the vessel, and began to push her up out of the water at one end! This extraordinary accident is admirably illustrated in our photograph. The *Turiste* sustained considerable damage, and it cost between £300 and £400 to repair her.

THE EXTRAORDINARY ACCIDENT TO THE "TURISTE."
From a Photograph.

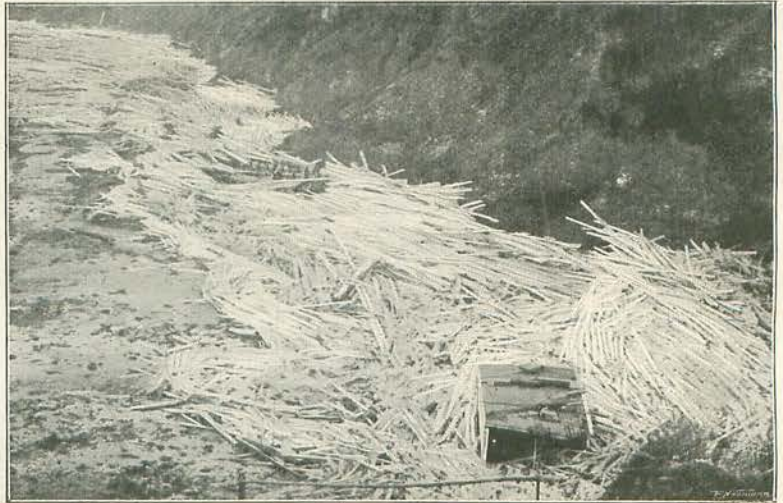
The last photograph reproduced shows the truly extraordinary wreck of the *Eviva*—a pathetic name for a ship that was utterly annihilated. The *Eviva* had come from Norway with a cargo of timber, when she was driven ashore at Fishguard and became a total wreck. Four consecutive photos. of the doomed vessel were taken, each

one depicting a later and more hopeless stage. The photo. we reproduce shows the last stage of the wreck. The material of which the ship was built, together with the planks that formed the cargo—these are strewn about in such astounding profusion that the whole looks, from a distance, like scattered straw. Of the ship scarce one plank remained joined to another. The salvaging of the *Eviva* was equally extraordinary. It was taken in hand by the famous old firm of Wendt and Co., of 4 and 6, Throgmorton Avenue, E.C., who kindly lent us this photo., and that of the *Turiste*. When Messrs. Wendt's representatives arrived at Fishguard, they found all the miners out on strike, so they naturally offered them the work of salvaging the wreck, or rather what was left of it. This the sturdy fellows refused to do, for some reason or other, and there was nothing left for Messrs. Wendt and Co. but to offer the work to the women and children, who undertook it gladly. What is more, they carried it

From a] "A WRECK INDEED"—LAST STAGE OF THE "EVIVA." [Photograph.
