A LIFE OF PERIL:

THE LANCASHIRE STEEPLEJACK AND HIS WORK.

BY GEORGE FALCONER.

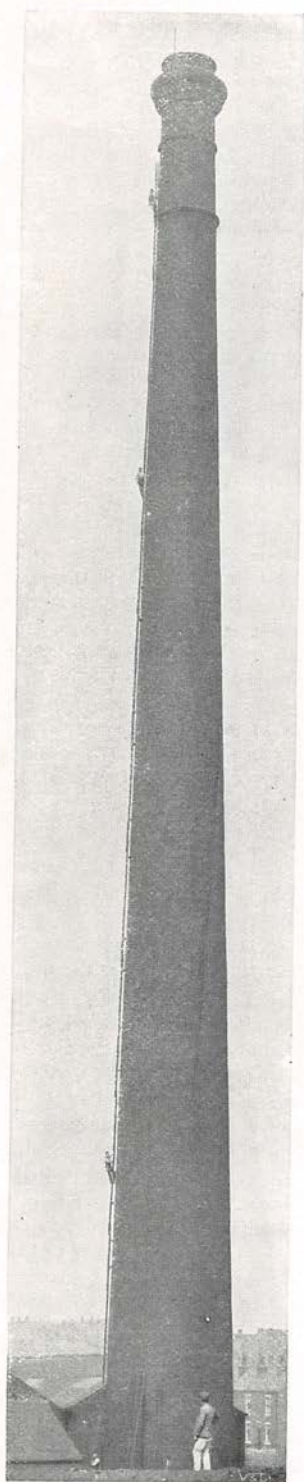
LADDERING A CHIMNEY.

In this instance the chimney was square in shape and measured about 170 feet in height. When we arrived, the men were busily engaged in laddering the structure. The ladders utilised for this purpose measure about 21 feet in length, and are so constructed that the maximum of strength is obtained with a corresponding minimum of weight. The steeplejack drove one of the

iron dogs firmly and deeply into the brickwork at the base of the chimney, securely lashed a ladder thereto, climbed to the top of the ladder, drove in another dog, hauled up a second ladder, firmly lashed that to the dog at the top of the first ladder, scaled to the top of the second ladder, drove in an iron dog, hauled up another ladder, and so on, until a continuous array of ladders stretched up one side of the chimney from its base to the summit.

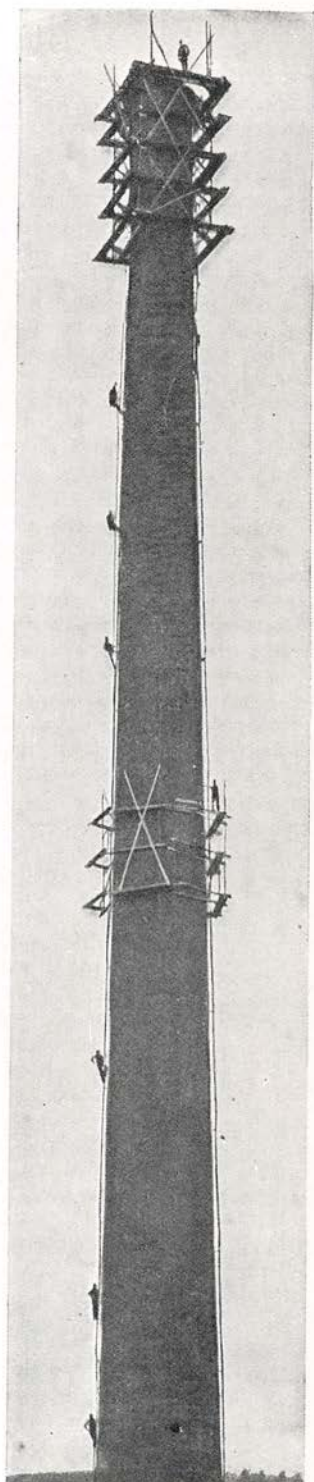
BELTING AND POINTING A
CHIMNEY.

The general repair necessary to a chimney, however, is pointing—that is, refilling the interstices between the bricks with new mastic, as time and weather deteriorate the old mortar. A scaffolding is generally erected around the summit of the stack, and from this seats are suspended

upon endless ropes run through strong pulleys, so that the workman can raise and lower himself at will. The scaffolding is constructed upon what is technically known as the "clip and pole" system. If sound materials are employed, and there is no bungling in the erection, it is absolutely impossible for it to collapse.

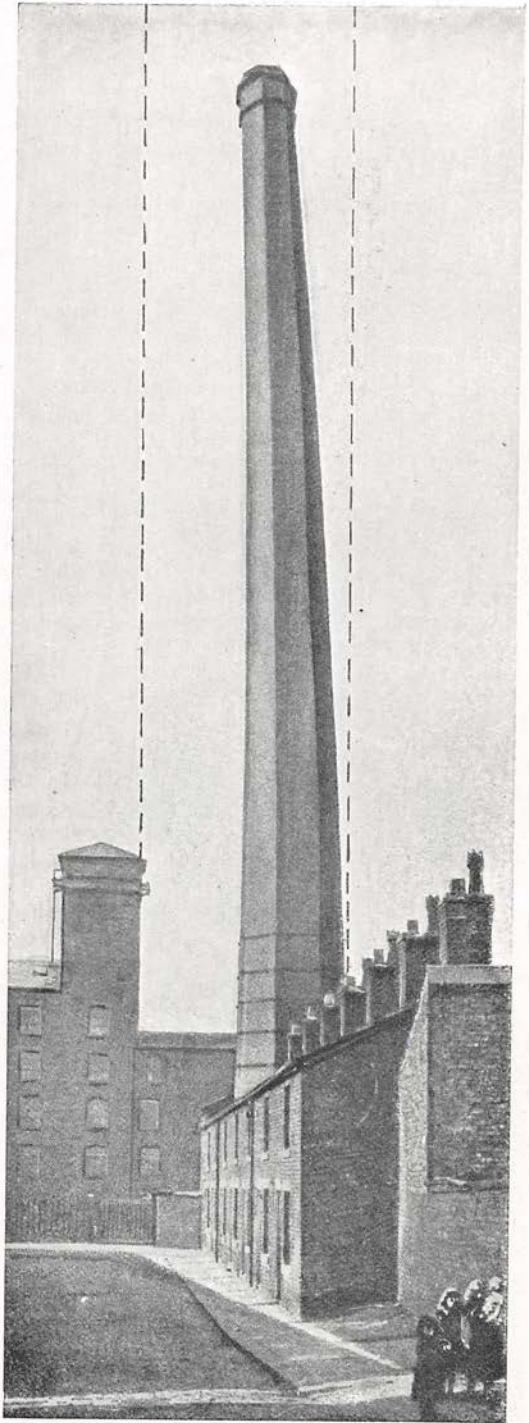
THE ENGLISH TOWER OF PISA—THE CROOKED CHIMNEY OF HEYWOOD.

While we were in Heywood, Mr. Smith showed me what may almost be termed the English "Pisa tower"—the leaning chimney. It certainly is the most crooked chimney in England, and when viewed in the same manner as shown in our illustration the effect is decidedly striking. It looks as if it must inevitably topple over, but Mr. Smith assured me that it is as safe as the straightest stacks. The proprietor exhibits a keen pride in this building freak, and spares no money upon its continual repair, so that the neighbouring inhabitants shall have no cause to doubt its stability. "No, I am completely at a loss to explain why it assumed this strange

position," commented Mr. Smith. "It listed over directly after its completion, but all I can say is that during the twenty years it has been in my hands it has not moved a quarter of an inch, notwithstanding the fact that it is 195 feet in height and represents a dead weight of 2,000 tons." The steeplejack could not satisfy my curiosity as to how much it listed from the perpendicular, but judging from our illustration it must be several feet. At any rate, the crooked chimney constitutes a "lion" of Heywood.

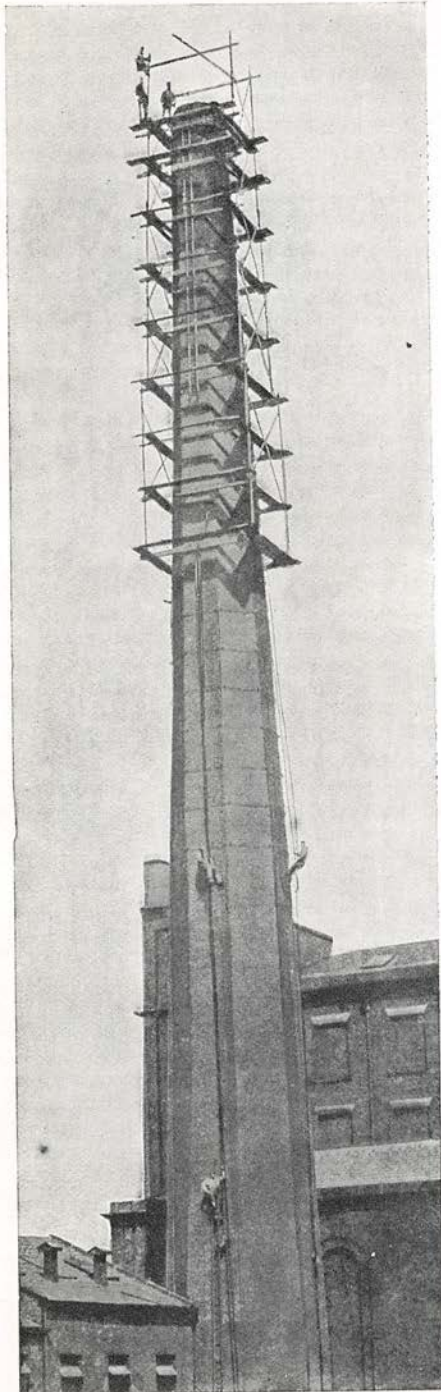
STEPLADDER JACKS AT WORK ON THE SIDES OF A CHIMNEY.

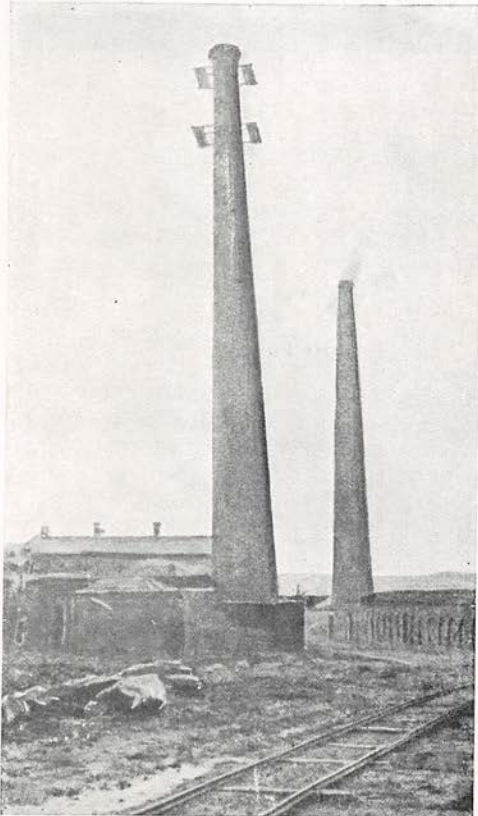
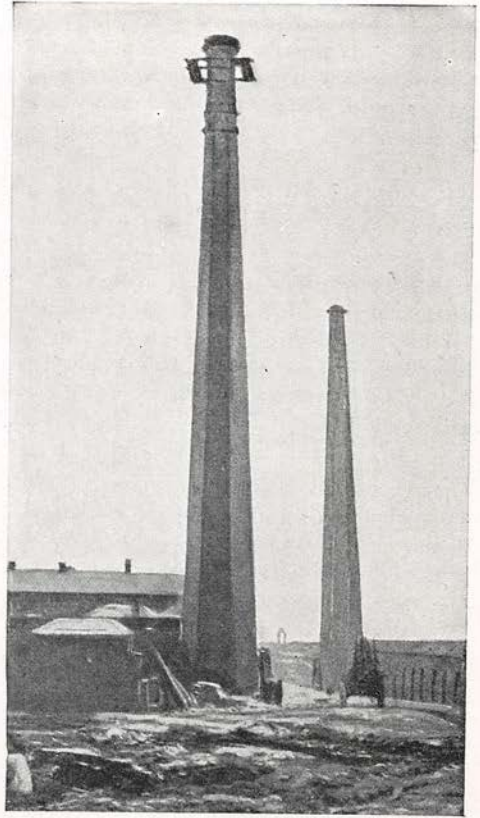
—AFTER.

STRAIGHTENING A CHIMNEY—BEFORE.

"One of the most perilous undertakings that I can remember in connection with chimney work," said Mr. Smith. "was the straightening of a large stack, 200 feet high. It was as much as 4 ft. 6 in. out of plumb. No, the reason for the listing was not through faulty construction, because the chimney itself was in sound condition, but the foundations had subsided on one side, causing the chimney to heel over to the extent shown in the photograph. I may tell you that when a chimney deviates as much as four and a half feet from the perpendicular it is a serious matter." To straighten the chimney the steeplejack removed a course of bricks from about two-thirds of the convex side. As he withdrew the bricks iron wedges were temporarily inserted. Sometimes the removal of one course of bricks is sufficient to bring a chimney back once more into the perpendicular, but in this case as many as four courses had to be removed. The chimney at this stage was mainly resting upon the iron wedges. Then came the crucial moment. The wedges were withdrawn one by one, and the apertures were filled with a thinner course of bricks and specially prepared

mortar. As the wedges were removed the whole chimney, obeying the laws of gravitation, slowly and steadily returned to the perpendicular.

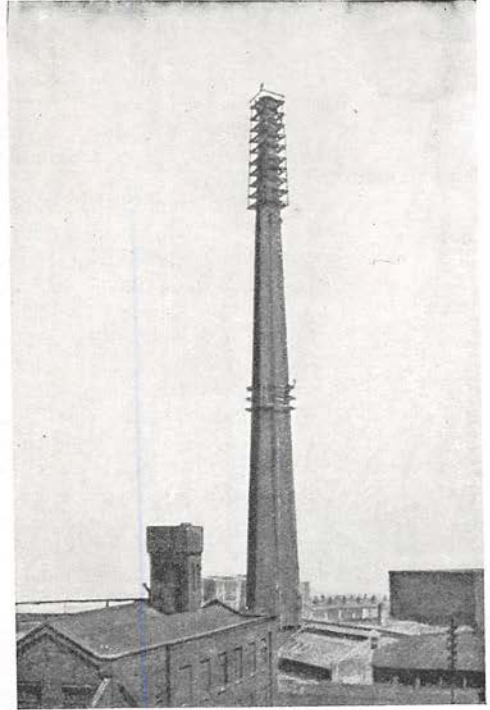
THE TALLEST CHIMNEY IN ENGLAND—367½ FEET IN HEIGHT.

"If you mean as regards dimensions," replied Mr. Smith, "it was undoubtedly the complete restoration of a massive chimney at Bolton. This stack, which is the property of the well known machine manufacturers, Messrs. Dobson and Barlow, exceeds the height of St. Paul's Cathedral, towering as it does 367½ feet into the air. It is the tallest chimney in England and the second tallest chimney in the world, the premier honour in this class resting with the famous Townsend stack of Glasgow, which is 489 feet

high. The following details will convey some idea of its mammoth proportions. It is octagonal in shape, and measures 127½ feet in circumference at the base, tapering away to 34 feet in circumference at the top, while nearly 1,000,000 bricks and 120 tons of stone were utilised in its construction. Having successfully laddered the stack from top to bottom, and erected the clip and pole scaffold around the summit, I found that the height was so great that it would not permit me to haul up the necessary repairing materials from the ground, as the ropes were drifted about in all directions by the wind.

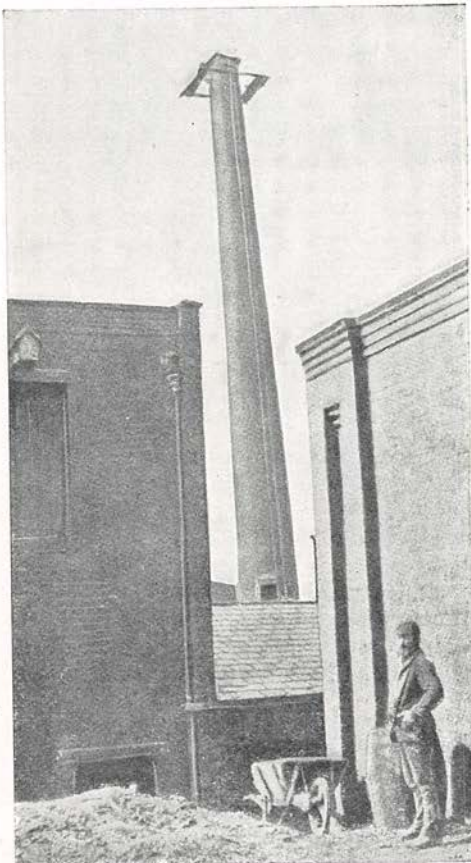
FOUR AND A HALF FEET OUT OF THE PERPENDICULAR.

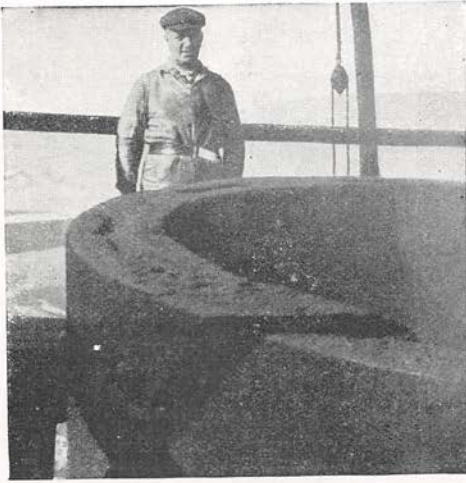
THE LANCASHIRE STEEPLEJACK AT THE SUMMIT OF THE TALLEST CHIMNEY IN ENGLAND, AND—

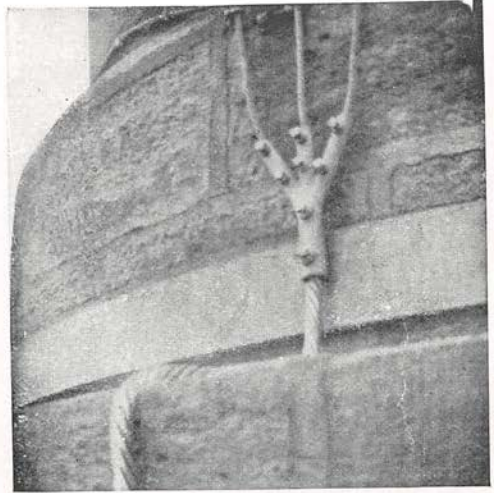
HOW HE FIXED THE LIGHTNING CONDUCTOR.

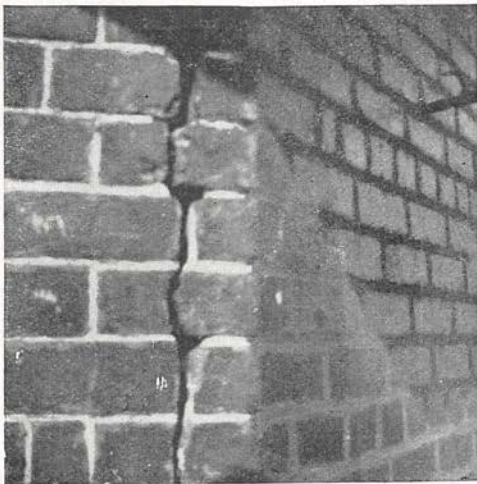
UGLY CRACKS EXTENDED DOWN THE SIDES FOR 150 FEET.

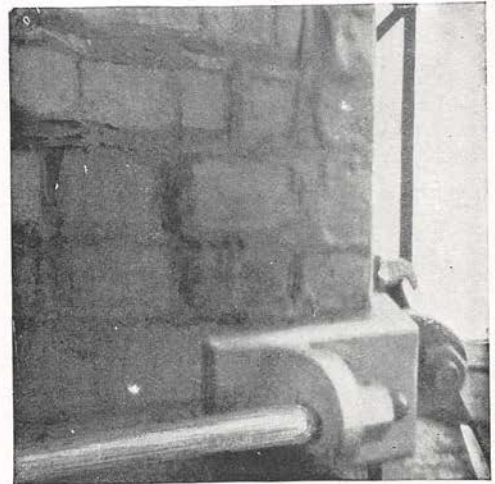
THE CRACKS REPAIRED AND THE METHOD OF BELTING AN OCTAGONAL CHIMNEY ILLUSTRATED.

excessive heat. In such cases a new lease of life is imparted to the structure by enveloping it with broad iron bands wherever necessary, in much the same manner as a cooper hoops his barrels.

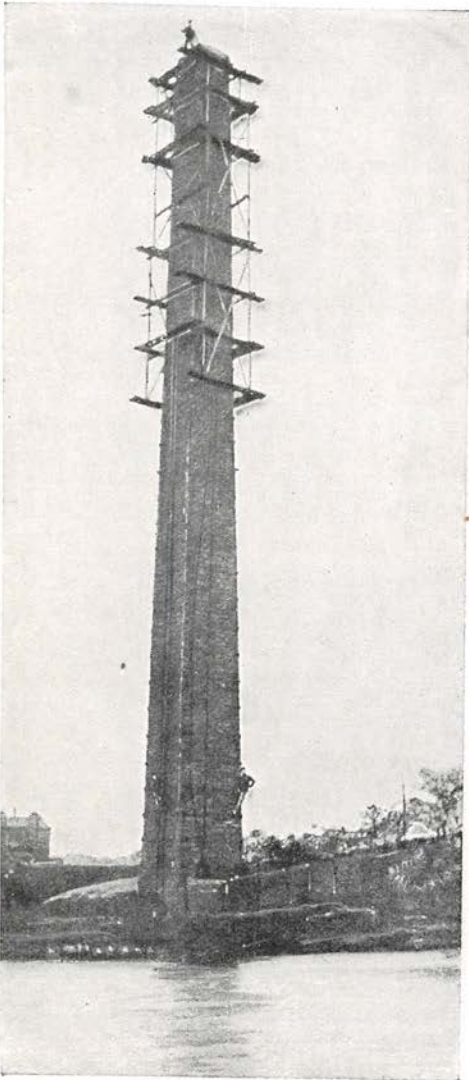
LENGTHENING A CHIMNEY,

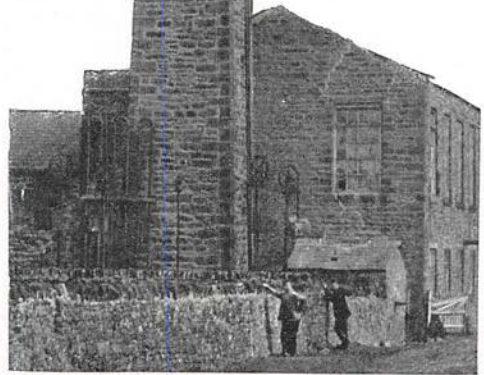
AN UNPROTECTED CHIMNEY THAT WAS STRUCK BY LIGHTNING AND REPAIRED BY MR. SMITH.

at the Spenbrook cotton mill was struck by lightning. A huge portion of the crown of the chimney, about eighteen feet in extent, was torn away and hurled through the roof of a shed below, in which the operators were at work. Fortunately, no one was injured, but there were some hairbreadth escapes. One large portion of the *débris* crashed on to a loom, but the weaver sustained no harm further than a shock. Another large stone plunged into a fully charged gasometer, and the gas exploded with a terrific report. The electric current, after passing down through the chimney, played among the looms in various parts of the building, and over seventy were ignited. Had it not been for the prompt action of the weavers in extinguishing the small conflagrations there is no doubt that the whole mill would have been gutted. As it was, damage almost to the extent of £600 was inflicted. Several of the mill proprietors, however, recognising the risks they run with unprotected chimneys, are having lightning conductors affixed thereto, so that injury arising from such accidents is now reduced to a minimum.

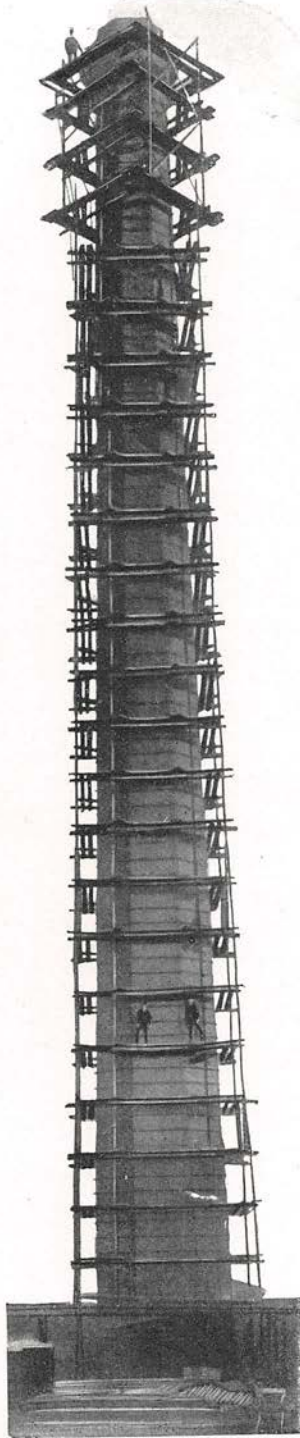
THE CHIMNEY AT THE ATLAS WORKS, BOLTON, THAT REQUIRED COMPLETE SCAFFOLDING IN ORDER TO CARRY OUT REPAIRS.

"One of the most remarkable instances of 'belting' that I can recall," said Mr. Smith, "was that of a chimney belonging to Messrs. Thomas Walmsley and Sons, at Bolton. This stack had to withstand an appalling force of heat, for between thirty and forty huge furnaces roared incessantly at its base, and the smoke and heat issuing from the daily consumption of one hundred tons of coal were evacuated through this one shaft. The result was that the chimney was cracked and bulged in all directions in the most startling manner. As it was impossible to erect a new shaft, I determined to encase practically the whole structure in iron from top to bottom. This was no light task, as the chimney was over 200 feet in height. Owing to the unusually heavy nature of the belting work I completely enveloped the stack in scaffolding. This alone took three weeks to erect. It

comprised twenty-seven platforms, while 400 feet of poles and 7,000 feet of scaffold planks were requisitioned." Our photograph comprehensively illustrates the heavy nature of this unique task, and also how thoroughly the chimney was belted. When Mr. Smith has repointed a shaft he applies a liberal coating of linseed oil to the masonry to protect it from the weather.
